Title: Chlorine Dioxide Coupon Exposure Report
Client: Arcoplast, Inc.
Project/Test Date: ARC07NPN / February 27, 2007
Report Version: March 8, 2007

TEST REPORT

The purpose of this report is to document the results of exposing material samples supplied by Arcoplast to typical, large-scale disinfecting conditions using chlorine dioxide [ClO₂] gas.

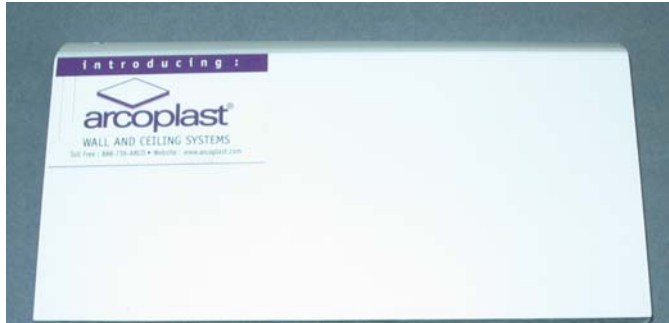
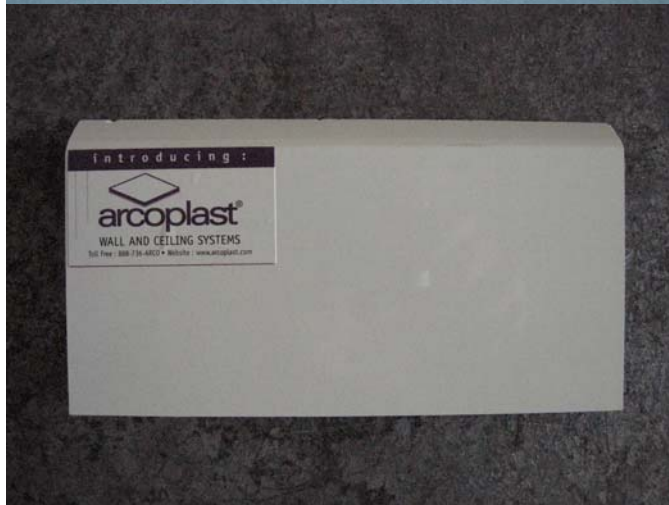
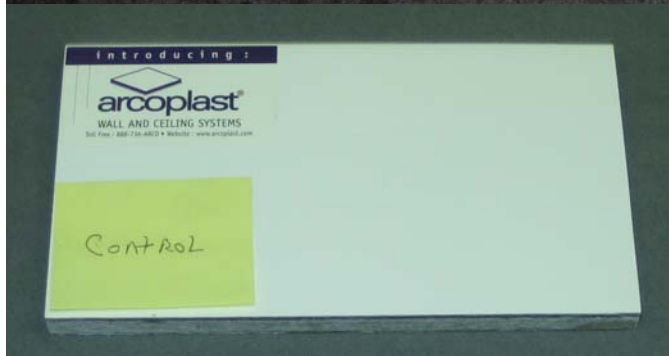
5.1 Coupon #1:

| CIO2-9 EXPOSURE TEST RESULTS | | |
|---|---|--|
| #1 | 6" X 3 1/4" | No visible change |

Coupon #1: after CIO2-9 run

Control coupon: No visible differences between the two coupons were observed.

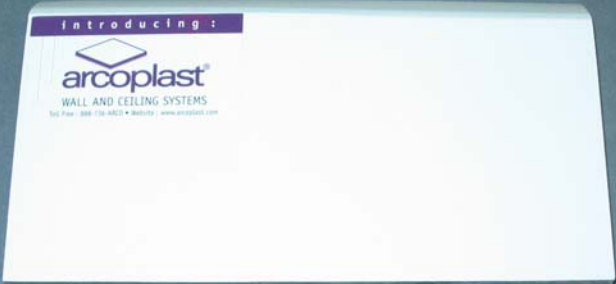
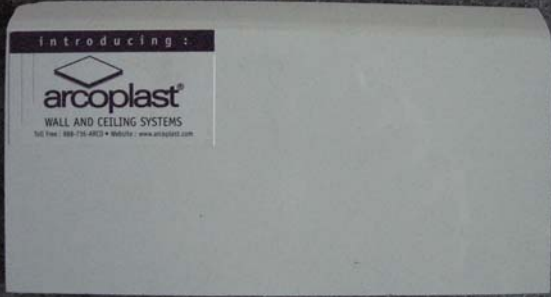
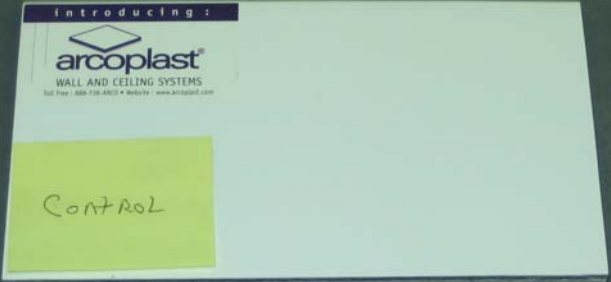
5.2 Coupon #2:

| CIO2-9 EXPOSURE TEST RESULTS | | |
|---|---|--|
| #2 | 6" X 3 1/4" | No visible change |

| | <p>Coupon #2: after CIO2-9 run</p> |
| | <p>Control coupon: No visible differences between the two coupons were observed.</p> |

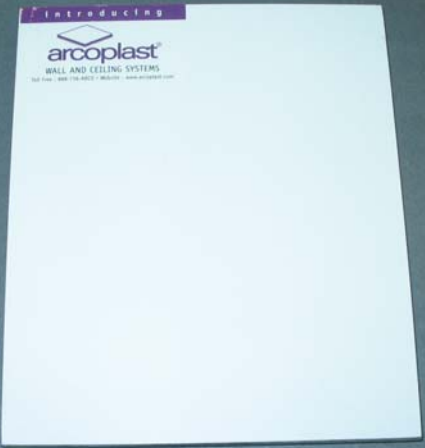
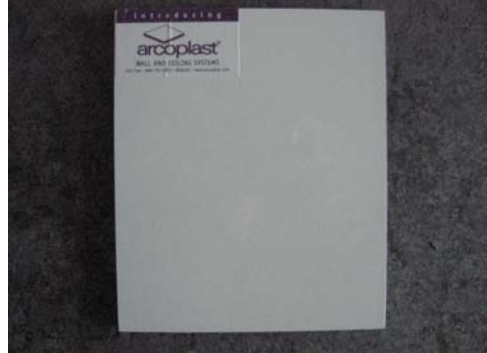
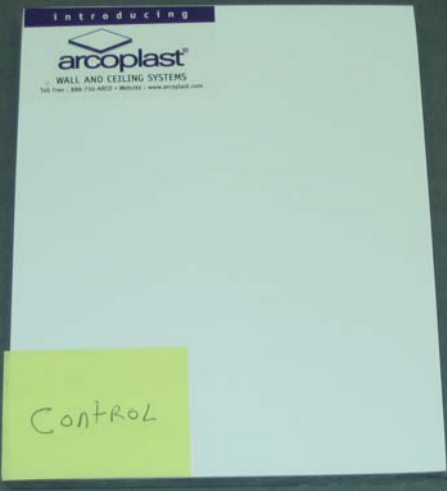
5.3 Coupon #3:

| CIO2-9 EXPOSURE TEST RESULTS | | |
|---|---|--|
| #3 | 6" X 5" | No visible change |

| | | <p>Coupon #3 after CIO2-9 run</p> |
| | | <p>Control coupon: No visible differences between the two coupons were observed.</p> |

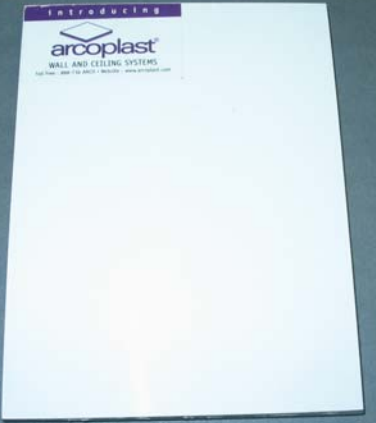
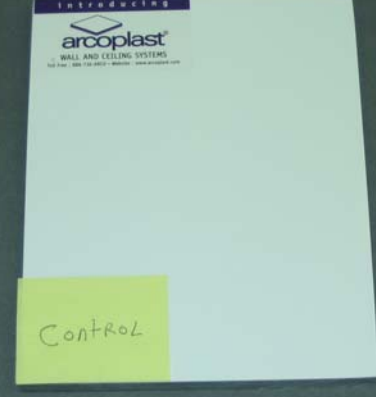
5.4 Coupon #4:

| | | <p>Control coupon: No visible differences between the two coupons were observed.</p> |

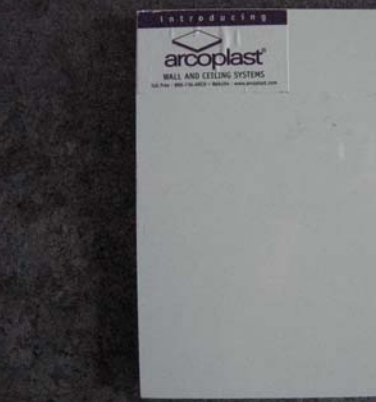
| CIO2-9 EXPOSURE TEST RESULTS | | |
|---|---|--|
| #4 | 6" X 4 1/4" | No visible change |

| | | <p>Coupon #4 after CIO2-9 run (note slight bubbling of label material only)</p> |

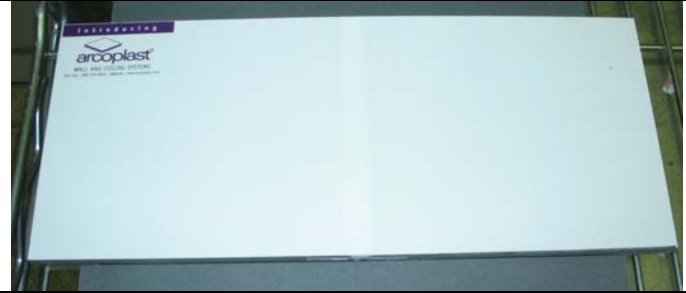
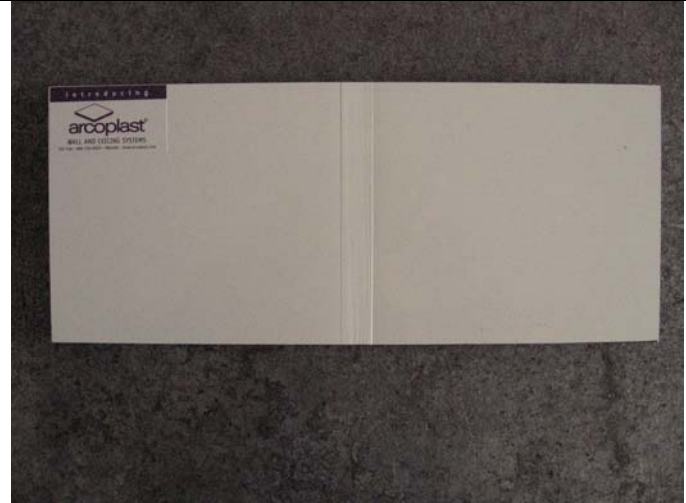
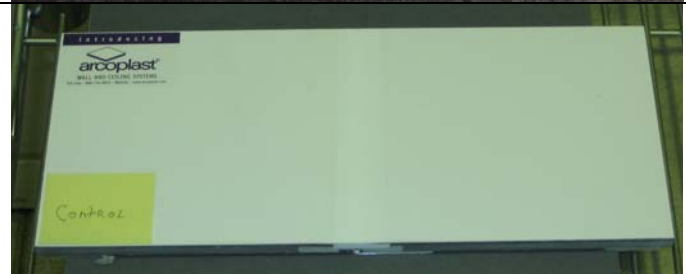
5.5 Coupon #5:

| CIO2-9 EXPOSURE TEST RESULTS | | |
|---|---|--|
| #5 | 11 3/4" X 5" | No visible change |

| | <p>Coupon #5 after ClO2-9 run</p> |
| | <p>Control coupon: No visible differences between the two coupons were observed.</p> |

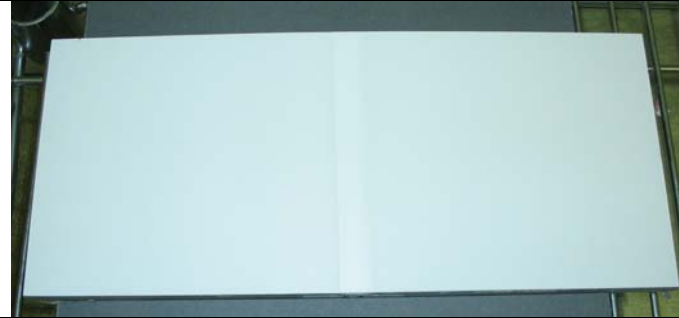
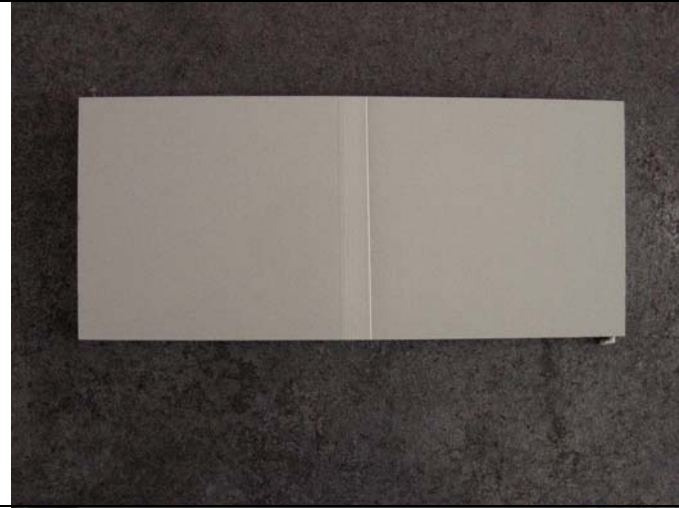
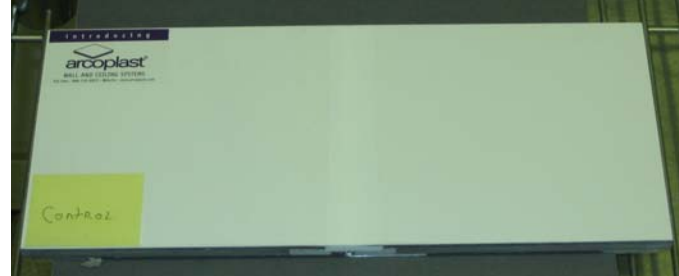
5.6 Coupon #6:

| CIO2-9 EXPOSURE TEST RESULTS | | |
|---|---|--|
| #6 | 11 3/4" X 5" | No visible change |

| | <p>Coupon #6 after ClO2-9 run</p> |
| | <p>Control coupon: No visible differences between the two coupons were observed.</p> |

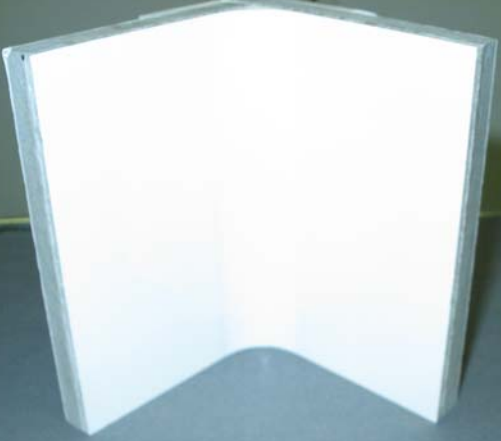
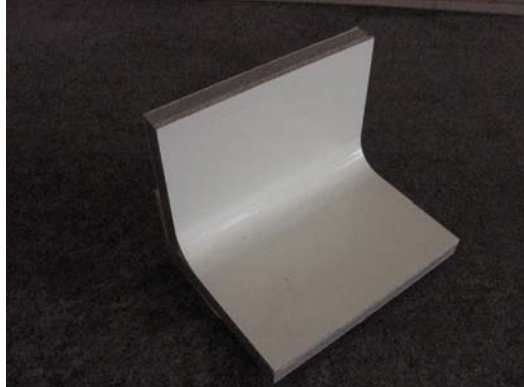
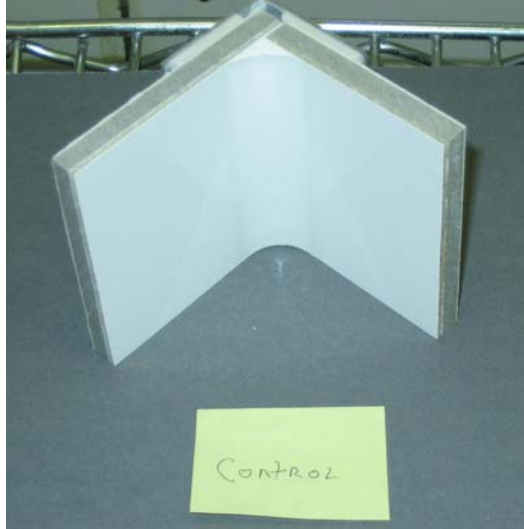
5.7 Coupon #7:

| CIO2-9 EXPOSURE TEST RESULTS | | |
|---|---|--|
| #7 | 3" X 3 1/2" (per 90° side) | No visible change |

| | <p>Coupon #7 after CIO2-9 run</p> |
| | <p>Control coupon: No visible differences between the two coupons were observed.</p> |

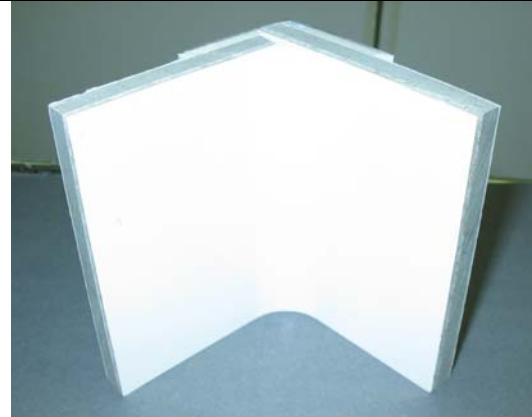
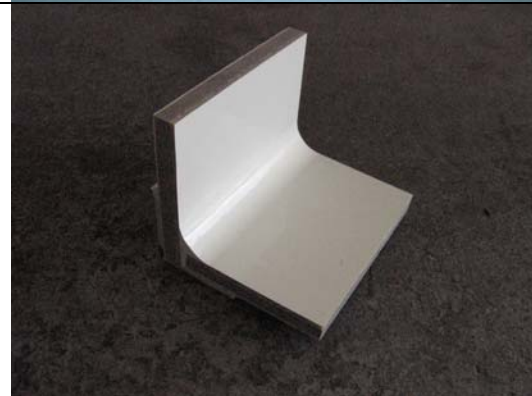
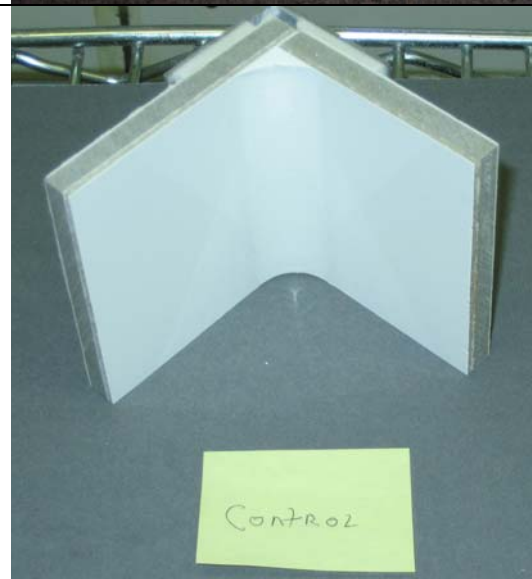
5.8 Coupon #8:

| CIO2-9 EXPOSURE TEST RESULTS | | |
|---|---|--|
| #8 | 3" X 3 1/2" (per 90° side) | No visible change |

| | <p>Coupon #8 after ClO2-9 run</p> |
| | <p>Control coupon: No visible differences between the two coupons were observed.</p> |

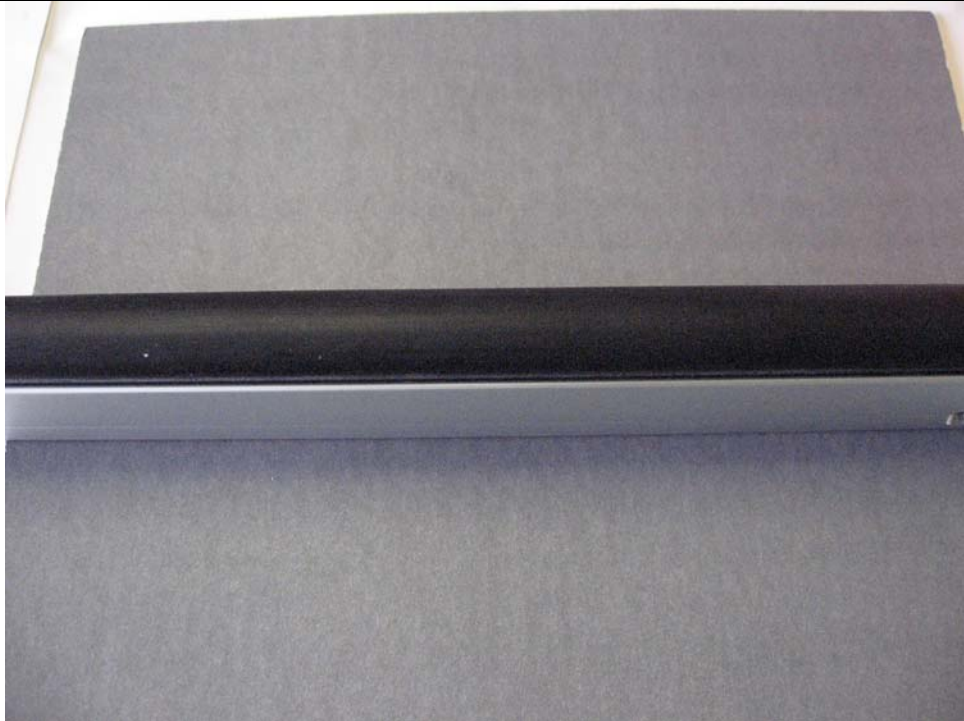
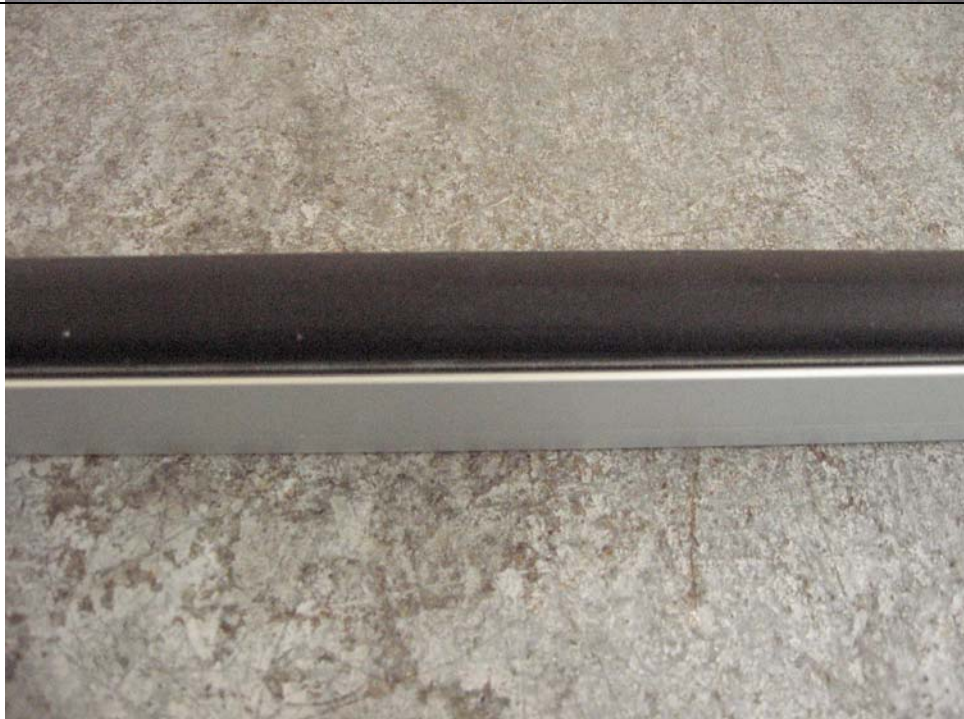
5.9 Neoprene Gasket:

- 3.4 The exposure of the samples to the chlorine dioxide gas caused no visible effect or damage to the surfaces of the coupons; neither the surface gel coat nor the finishing material was visibly affected. The sample of Neoprene gasket material was also unaffected; it did not shed/slough material in an ad-hoc smear test nor was its elasticity notably affected.

| CIO2-9 EXPOSURE TEST RESULTS | | |
|---|---|--|
| Neoprene | ~1" X 12" in Aluminum Support | No visible change |

| | <p>Neoprene gasket after ClO2-9 run. No visible differences between the before and after conditions</p> |
