VACUUM DECAY TEST REPORT

ARCOPLAST, INC.

**PRODUCT: Arcoplast Composite Wall
and Ceiling Liner Panel System**

Report No: 62525.01-106-31
Test Date: 04/13/06
Report Date: 05/19/06
Expiration Date: 04/13/10
Revision 1: 06/29/06

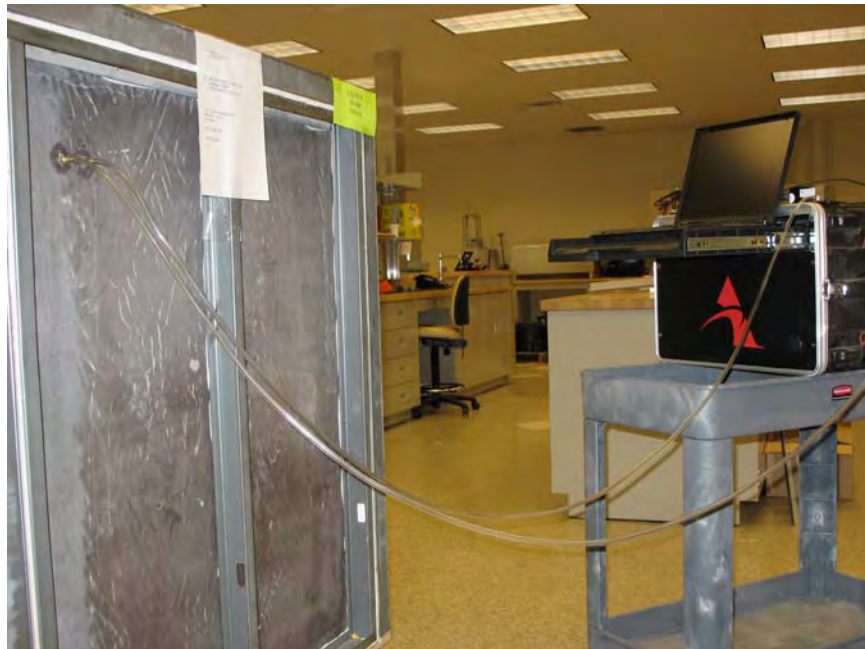
Photo No. 2
Connection of Module to Computerized Data Collector

Test Procedure: All testing was performed with a vacuum pump and vacuum sensor calibrated immediately prior to use. Vacuum measurements for the decay were taken at 10 second intervals throughout the test by means of a computerized recording device. The vacuum pump and sensor were attached to the module by drilling through a wall of the preassembled module, cutting threads into the holes and inserting two barbed hose connectors. A seal was then placed around the hose connector/wall joint using silicone-based sealant and allowed to cure for 24 hours prior to test. The vacuum pressure was applied until a level of 1000 Pa was achieved. The equivalent water column height to a vacuum of 1000 Pa is 4 inches.

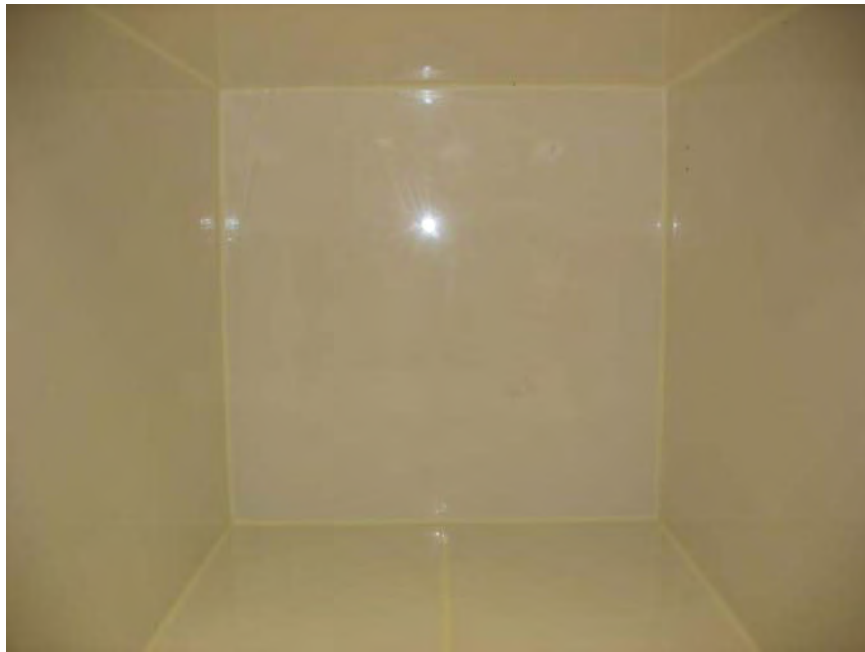
Photo No. 3
Interior View of Chamber Showing Corner and Butt Joint Seams

The values reported in this report represent calculated decay rates based on a zero opening sealed module as reiterated in the photographs attached to this report. This test does not include any openings, ventilation systems, or other components as may be provided by others and is applicable only to the wall panels and the joint seals between panels.
